Sometimes It's the

By Steven R. Southard,
Naval Sea Systems Command Deep Submergence Branch

Simple Things . . .

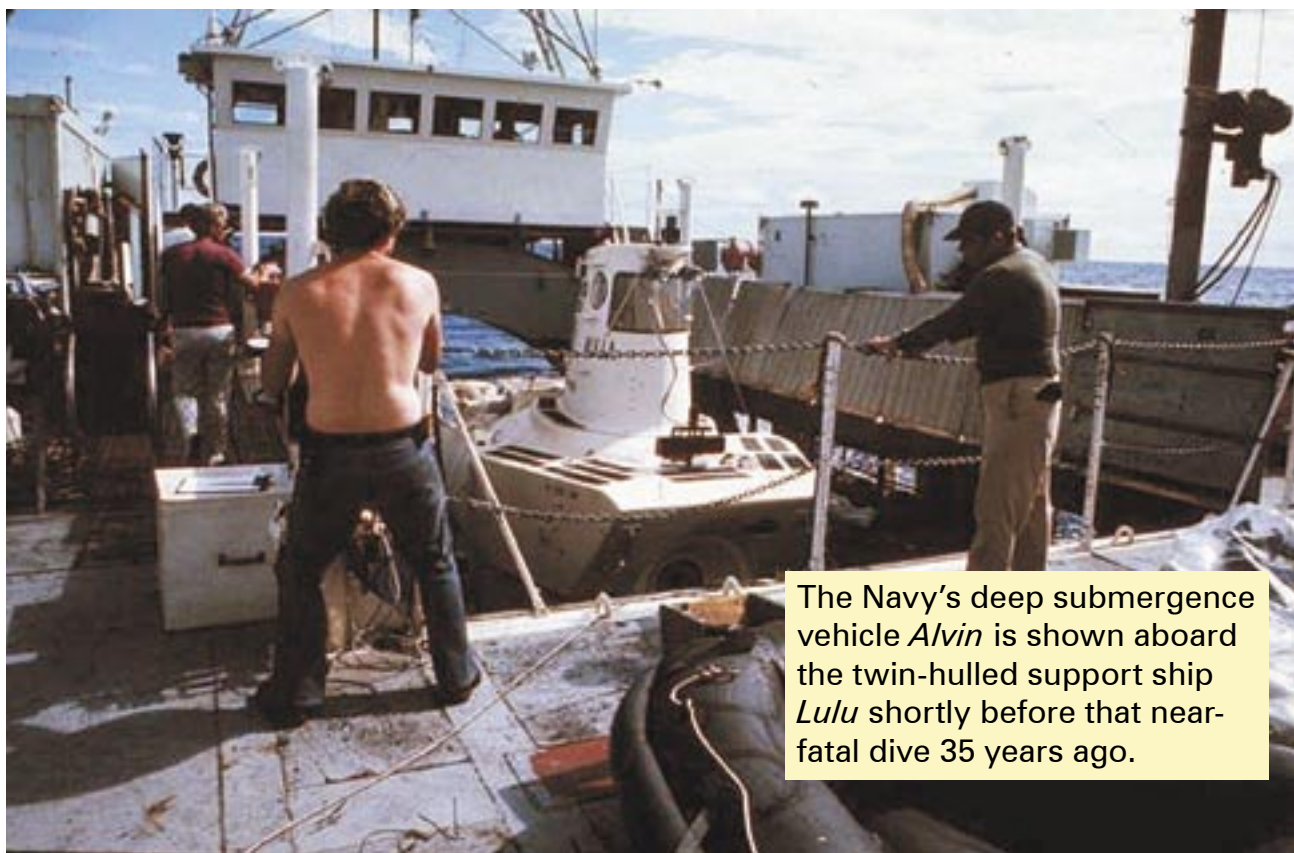
The Navy's deep submergence vehicle *Alvin* is shown aboard the twin-hulled support ship *Lulu* shortly before that near-fatal dive 35 years ago.

Operators had lowered the cradle about a foot when both forward end cables parted almost simultaneously. A hydraulic line in the port winch motor ruptured at about the same time.

Alvin slid off her cradle and briefly submerged. When she bobbed back to the surface, Bland leaped to safety, but Stimson and Weaver had to scramble through the small hatch while sea water was pouring in. Fortunately, minor cuts and bruises were the only injuries sustained. Line handlers struggled for about a minute to keep the 14-ton submersible on the surface, but the weight of inrushing water proved too great, and *Alvin* plunged to the bottom in 5,000 feet of water.

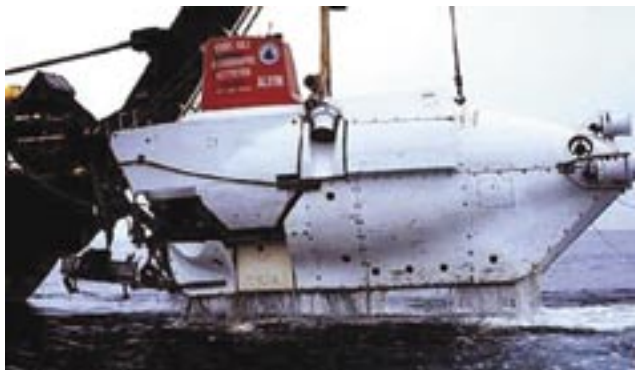
A year after sinking, *Alvin* comes to the surface, having been recovered by the privately owned submersible *Aluminaut*. The craft was refurbished and continues to serve the Navy.

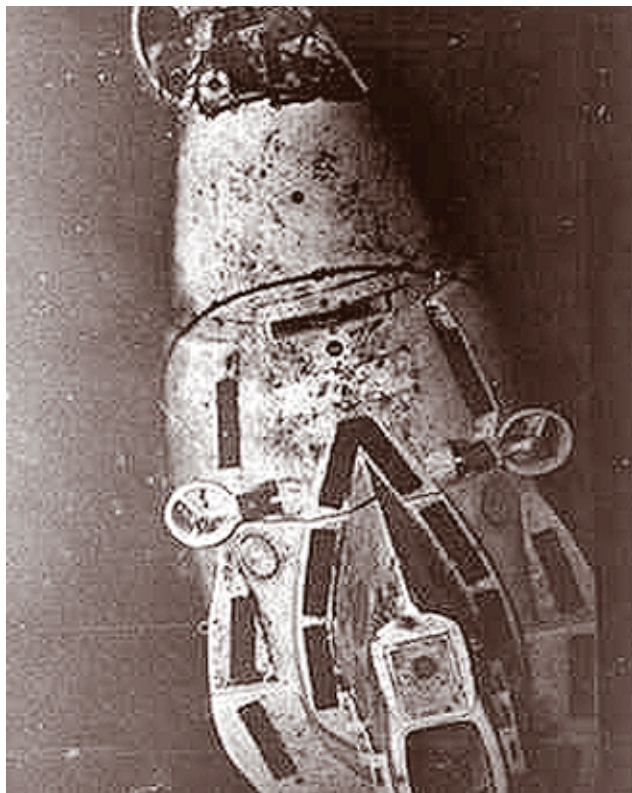
A camera from the submersible *Aluminaut* looks down on *Alvin* as the submersible rests on the ocean bottom almost a mile below the surface.

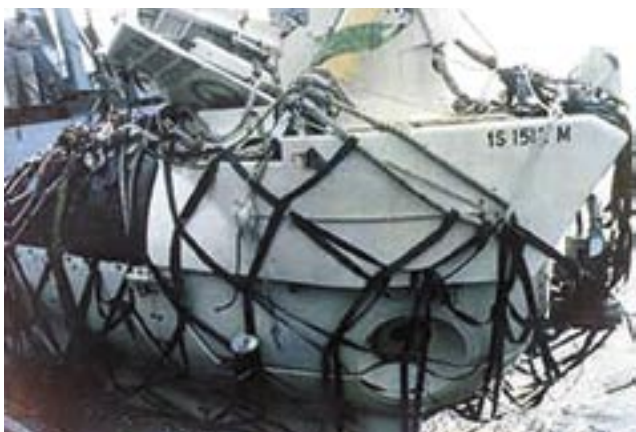
Quite a catch! *Alvin* is shown on the surface in a retrieving net upon recovery after spending a year on the ocean bottom almost a mile down.

Approximately a year after *Alvin*'s plunge to the bottom, the privately owned submersible *Aluminaut* raised her to the surface.
